GREAT COVE WATERSHED MANAGEMENT PLAN TOWN OF ISLIP

Nelson, Pope & Voorhis, LLC
www.nelsonpopevoorhis.com

**GREAT COVE
WATERSHED MANAGEMENT PLAN**

SEPTEMBER 2012

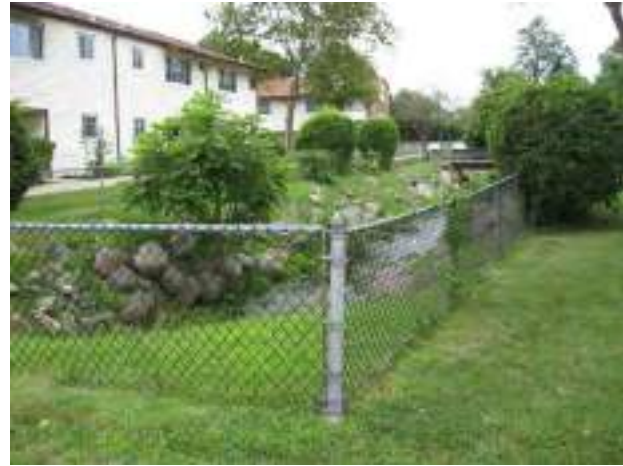
As noted on the Drainage Infrastructure Map for Project 3, a series of outfalls line Penataquit Creek between the Long Island Rail Road (LIRR) tracks and Union Blvd. east of Lakeview Ave. This property is a Town-owned parcel improved with a multifamily housing project. Penataquit Creek traverses the housing project and the Creek is directed into culverts below the housing site's parking lots on the north and south sides of property. In the central portion of the housing project, the Creek side slopes are stabilized with small rip rap, and lawn meets the Creek's edge in the majority of the site. Area drains collect stormwater within the existing lawn areas, which is then discharged directly to the outfalls located along Penataquit Creek. Overland flow of stormwater was also observed to be directed to the Town housing project's drainage system from a portion of Lakeview Ave. and an existing salvage yard located northwest of the property.

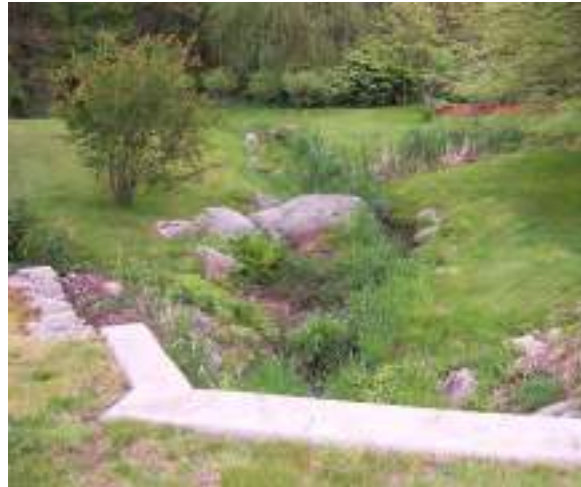
- Removal of the existing direct discharge to Watchogue Creek via the grated inlet in the parking area.
- Installation of subsurface leaching chambers or galleys in the central portion of the parking lot to provide for subsurface infiltration of stormwater. A portion of the parking lot area would need to be regraded to provide new low points to collect stormwater and divert it into the proposal linear infiltration system. An overflow from the linear collection system would be provided to Watchogue Creek for larger storm events.
- Installation of a biorention area in the existing lawn area adjacent to the west of the Creek. Stormwater runoff presently directed to the Creek from Mechanicville Road and Smith St. would be directed to the biorention area for filtration prior to overflow to the Creek

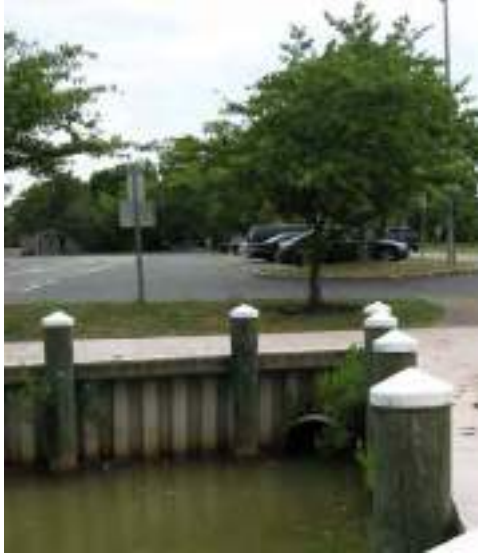
The Gibson St. parking area is a Town-owned parcel located adjacent to the west Watchogue Creek where the Creek daylight south of the Bay Shore business district. The Town recently completed a bulkhead replacement and created a park area surrounding the bulkhead including

benches and lighting improvements. Several large diameter outfalls discharge to Watchogue Creek at this location. Field observations and the Drainage Infrastructure Map indicate that stormwater runoff from the surrounding streets and improvements is conveyed and directly discharged to these outfalls. This parking area is relatively small in size and is used most intensely during summer months as overflow parking for the nearby ferries, with only limited use during winter months. The parking lot's size, location and use patterns make this parking area an ideal candidate for several small scale stormwater demonstration projects. The drainage improvements proposed in this location could be installed and monitored for performance and consideration for future larger scale installations. The stormwater demonstration projects could include:

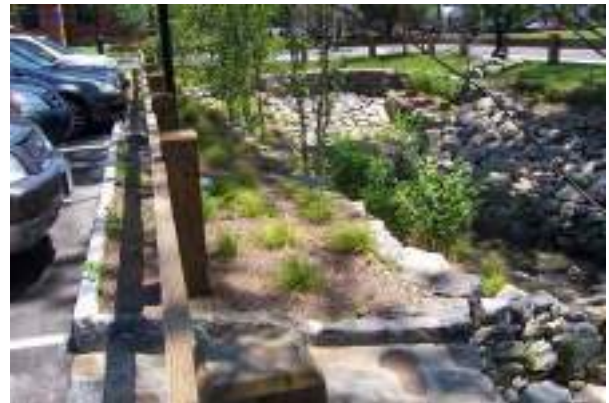
- Installation of permeable or porous pavement in a portion or throughout the parking lot. This location is relatively close to the Town's 2nd Ave. highway yard, which would allow for regular monitoring of the porous pavement. As the lot is not regularly utilized during winter months, plowing and salt/sanding could be restricted or tested in a portion of the lot. Additionally, given the site's proximity to downtown Bay Shore and to the adjacent park area, signage discussing the innovative green infrastructure improvements at the site would be readily visible and could provide positive educational opportunities.

- Installation of a diversion manhole to redirect stormwater runoff from the roadway conveyance system to a stormwater treatment structure. If the site were improved as a demonstration site, this location would provide an ideal location for testing and monitoring a stormwater treatment structure with filter media. Water quality in the Creek

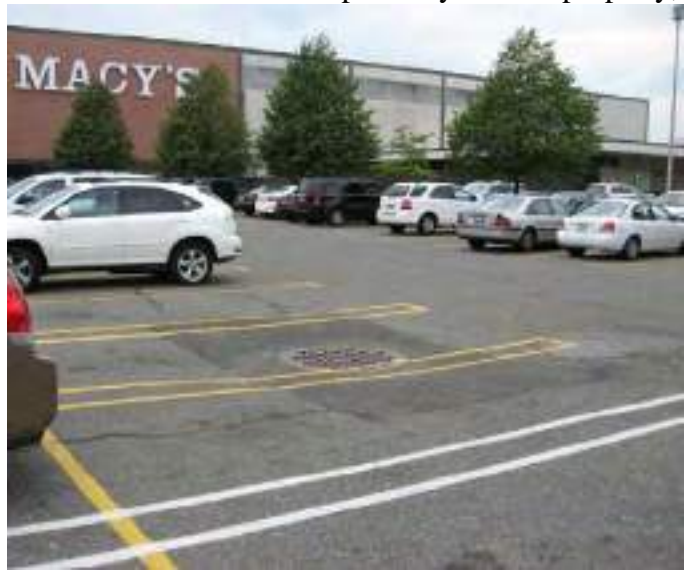
As described above and in Section 2.2.1.6, Penataquit Creek has shown very few signs of water quality improvement and in many cases its water quality has worsened since 1980. Elevated levels of bacteria, nitrogen, total phosphorus, and particularly sodium and chloride levels are extremely elevated. Both the Town and the South Shore Mall salt storage sites are in proximity to the Creek and appear to continue to impact water quality by salinizing fresh water streams, making them toxic to aquatic life. While the South Shore Mall is a privately owned property, Penataquit Creek runs directly below the mall parking lot in a 2,600 foot underground pipe. Drainage infrastructure within the east and a portion of the south sides of the mall parking area includes a series of grated inlets that discharge directly to Penataquit Creek. Water quality monitoring indicates that sodium presents a significant water quality problem, and frequently has been more than double the 20 mg/L NYS standard. Salt is stored in an uncovered mound in the northwest parking area of the mall during winter months. Additionally, salt applied to the parking area is washed directly into the Creek via the existing grated inlets to the subsurface pipe. Improvements are necessary to both the salt storage practices and drainage infrastructure on the property. Recommendations include:

- Establish a formalized and covered salt storage area with an elevated impervious floor to prevent runoff from entering the pile. Locate store pile away from existing drainage inlets and Penataquit Creek.
- Establish linear biorention areas at each existing drainage inlet which directly discharges to the Penataquit Creek culvert (along the eastern portion of the parking lot). The existing drainage inlets would be raised and biorention area planted around each inlet to allow for

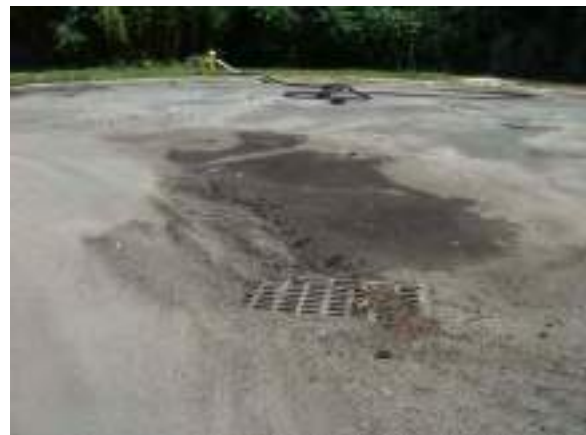
As described above, water quality within Penataquit Creek has been impacted from a variety of pollutants carried in stormwater runoff from adjacent land uses. The 2nd Ave. Highway Yard is located between Harrison Ave. and 2nd Ave., just west of Penataquit Creek. The yard is used for highway vehicle storage and maintenance, and includes an area on the southeast corner of the site where street sweepers and maintenance vehicles are washed. The existing drainage system within the Highway Yard consists of a series of catch basin inlets which collect stormwater, which is then conveyed to an outfall directly to Penataquit Creek. The Town retrofitted the catch basins within the parking lot area with catch basins inserts several years ago. Site observations described in Section 4.1 note that catch basins were filled with sediment and sediment was accumulated throughout the parking lot, particularly in the southeast corner of the yard in the vicinity of the truck washing area and along the eastern portion of the parking lot. The Town also operates a salt storage yard opposite the

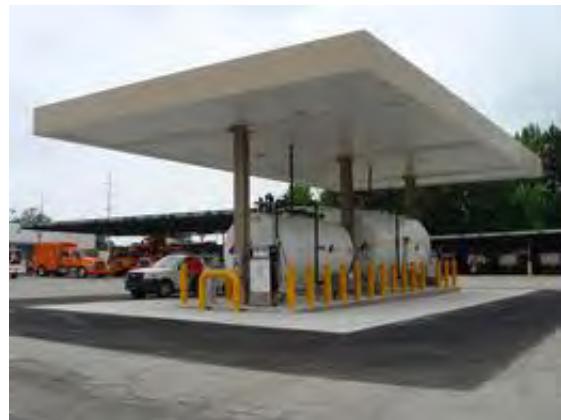
Highway Yard on the west side of 2nd Ave. Two covered salt storage structures are located in the western portion of the parking lot and a fueling station is located in the southeast portion of the property, near the site access. Field observations of existing drainage inlets within this parking lot and on the adjacent street did not find evidence of a positive overflow connection to the Highway Yard drainage system or direct discharge to the Creek. A drainage inlet is located immediately adjacent to the fueling station. The following recommendations for drainage/good house keeping improvements are provided:

- Retain and establish a regular monitoring and maintenance schedule for existing catch basin inserts to ensure proper functioning.
- Install leaching pools to intercept stormwater from the existing positive overflow to provide for infiltration of stormwater and reduce runoff directed to Penataquit Creek.
- Provide canopy for the existing fuel pump at the salt storage yard and install water treatment structure or catch basin insert at the existing inlet adjacent to the fueling pump.
- Provide a truck washing area with independent collection and recycling of waste water (do not allow for overflow to existing drainage system in parking area).
- Establish perimeter barriers for stockpile areas to avoid “creep” of stockpiles and spread of sediment within parking areas.
- Establish regular maintenance schedule for collection and proper disposal of sediment within parking lot areas.

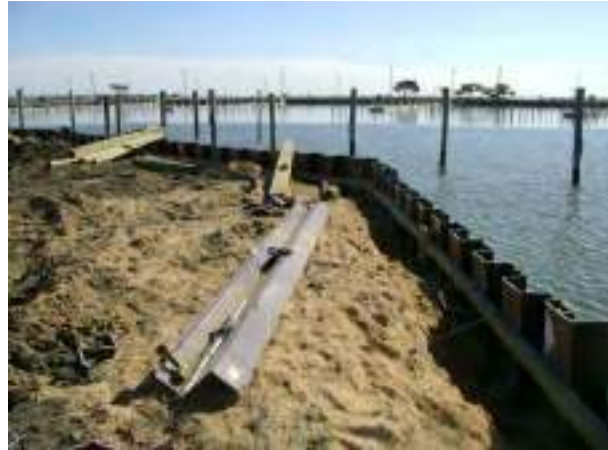
of stormwater to the outfall in the northeastern portion of the parking lot is not possible due to the low lying nature of the surrounding area, tidal fluctuation, and high groundwater conditions.

The bulkhead is in need of replacement and represents an opportunity to provide proper drainage and removal of direct stormwater discharges. The top of the bulkhead elevation should be raised and the parking lot re-graded to direct stormwater to newly established low points and drainage inlets within the parking area. Stormwater once collected should be directed to a water quality treatment structure designed with a high flow bypass to prevent flooding during large storm events.

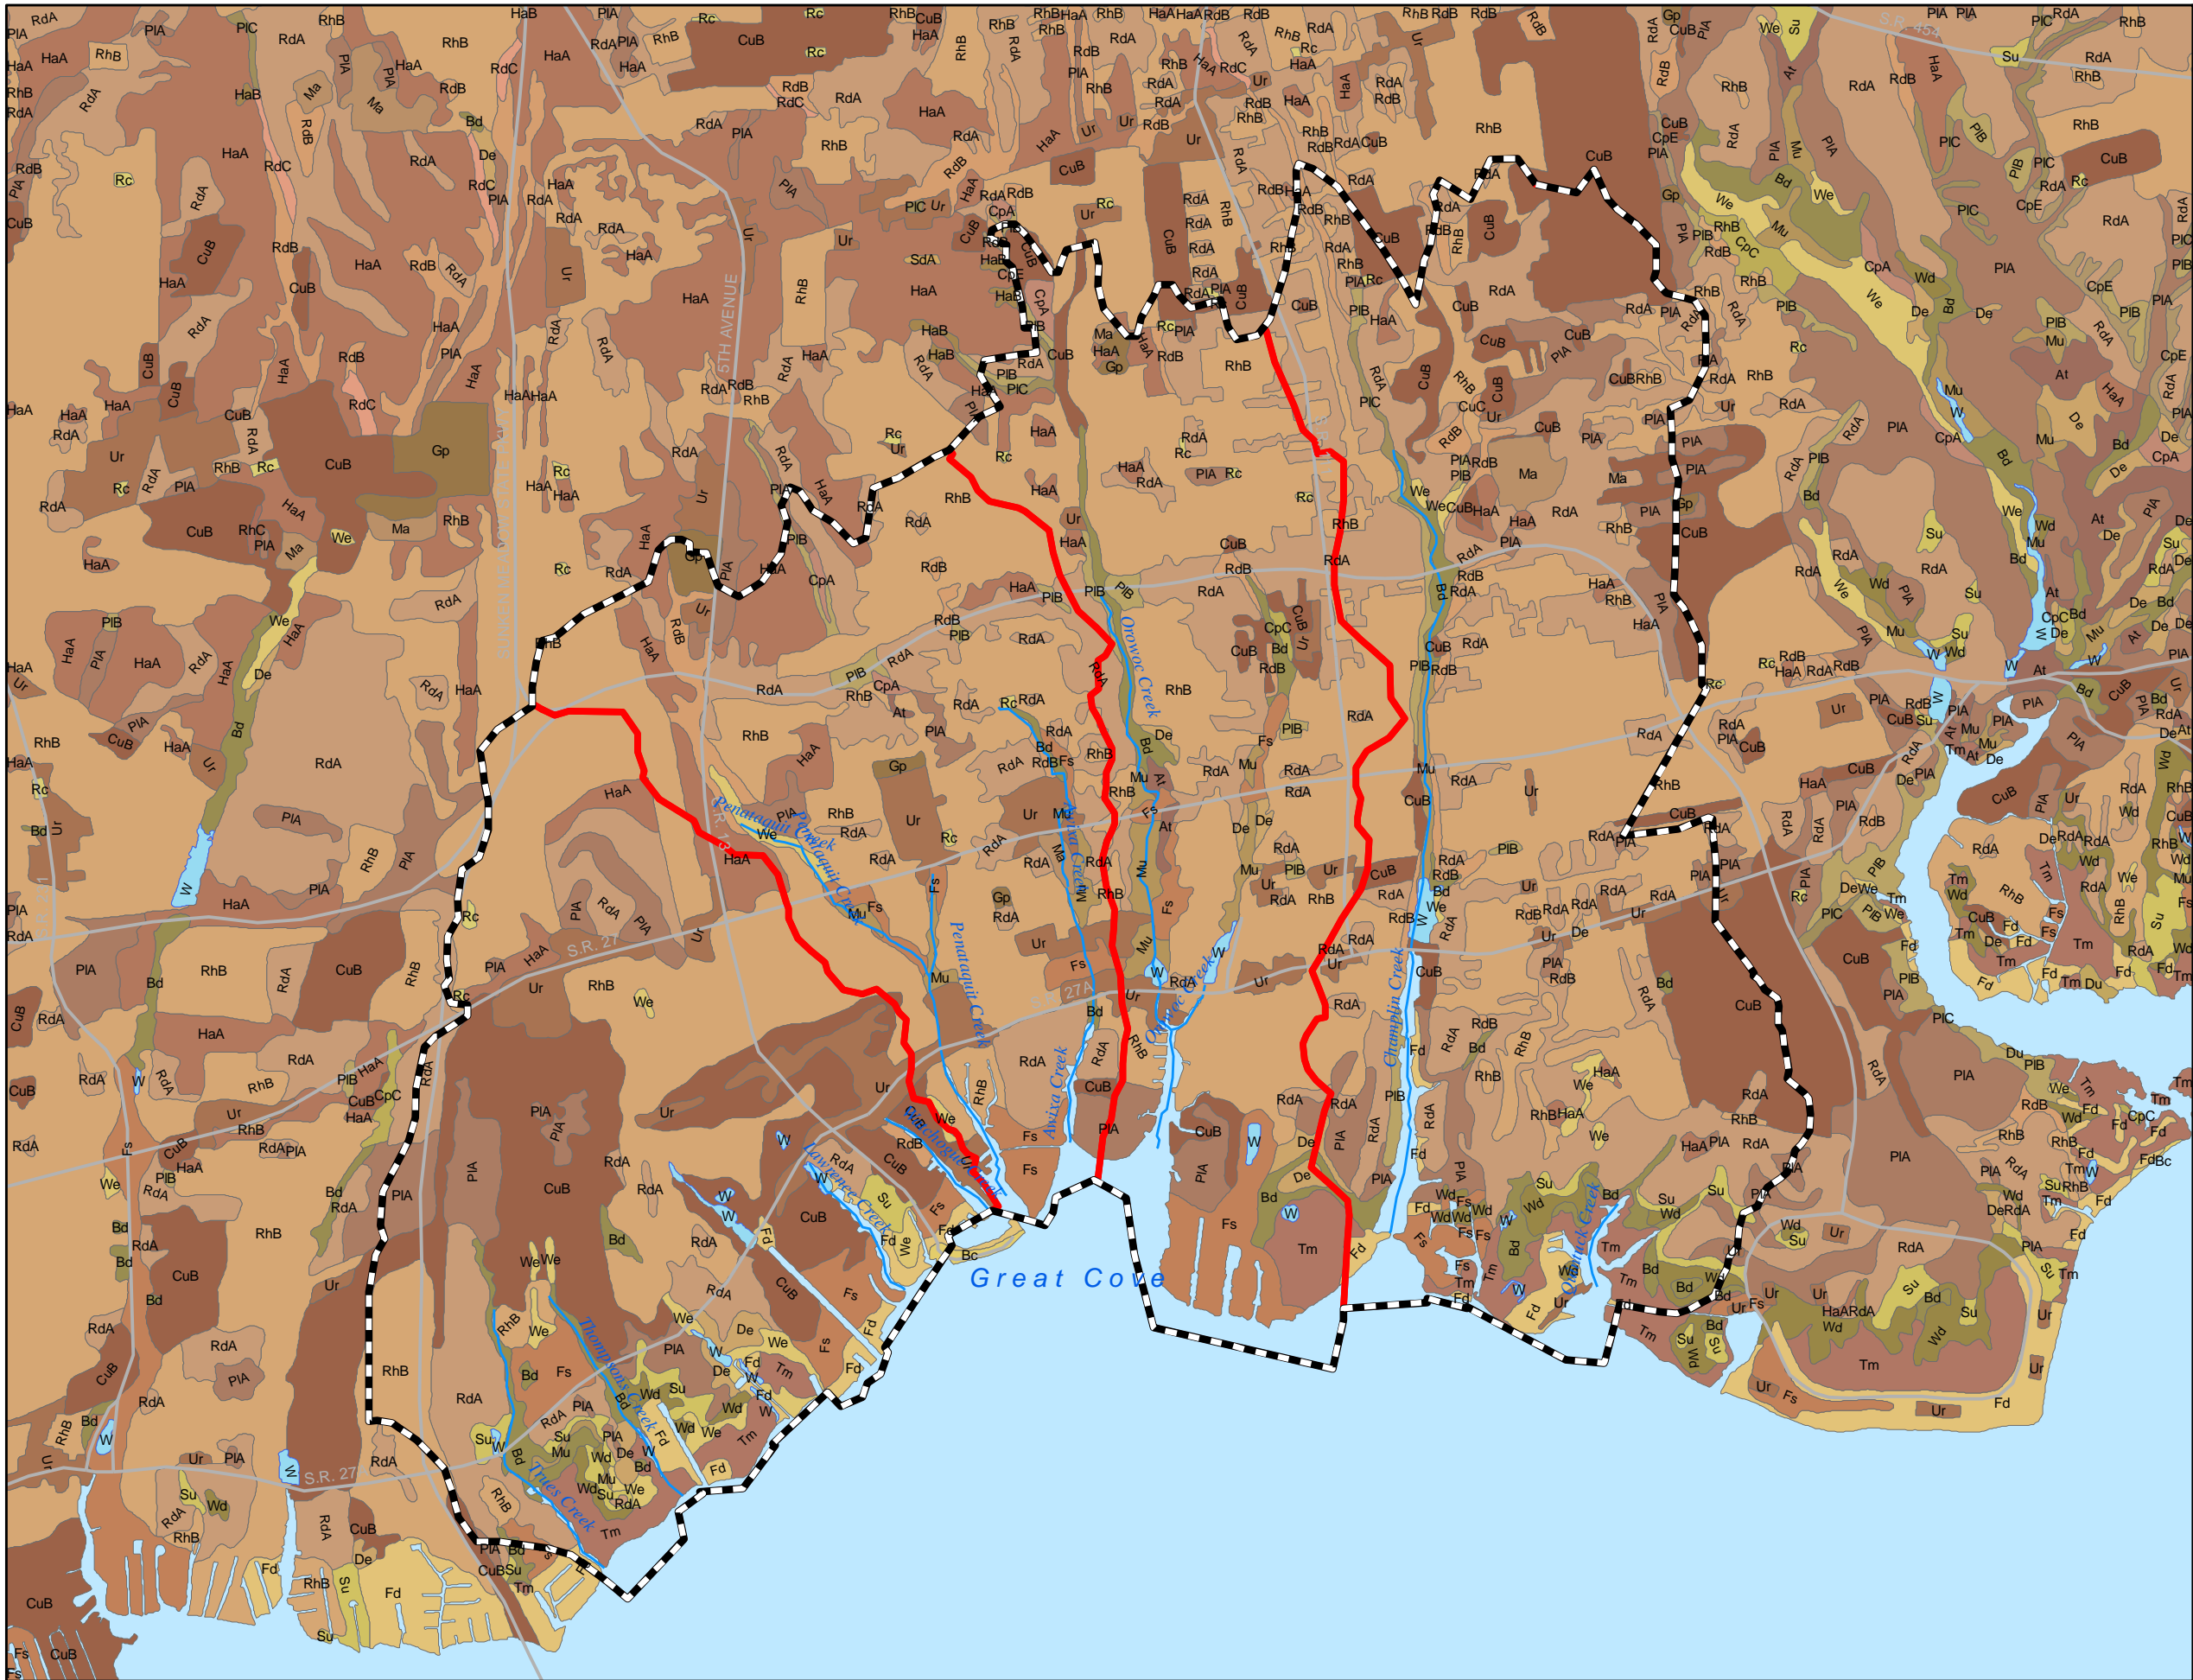
**FIGURE 2-2
SOILS MAP**

The predominant soil types located within the watershed as depicted in **Figure 2-2** consist of CuB (Cut and Fill land), PlA (Plymouth Loamy Sand), RdA (Riverhead Sandy Loam) and RhB (Riverhead and Haven soils), which are generally excessively drained to well drained. Significant quantities of Bd (Berryland Mucky Sand) Fd (Fill Land, Dredge Material) Fs (Fill Land, Sandy), HaA (Haven Loam), Mu (Muck), RdB (Riverhead Sandy Loam), Tm (Tidal Marsh), Ur (Urban Land) and We (Wareham Loamy Sand) are present within the watershed. Bd, Mu, Tm, and We soils are all poorly drained and are mainly located in areas adjacent to the individual creeks. Other soils present within the watershed include At (Atsion Sand), Bc (Beaches), CpA, CpC and CpE (Carver and Plymouth Sand), Gp (Gravel pits), Ma (Made Land), PlB and PlC (Plymouth Loamy Sand), Rc (Recharge Basin), Su (Sudbury Sandy Loam) and Wd (Walpole Sandy Loam). **Table 2-1** below provides a quantification of each soil type within the watershed in addition to the drainage category the soil type falls within.

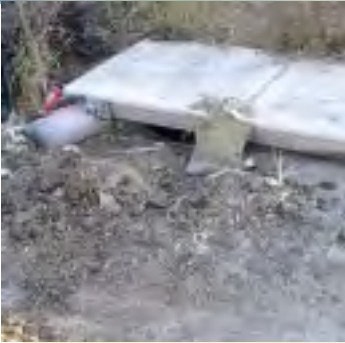
Stormwater runoff occurs when precipitation from rain or snowmelt flows over the ground. Impervious surfaces like driveways, sidewalks, and streets prevent stormwater from naturally soaking into the ground.

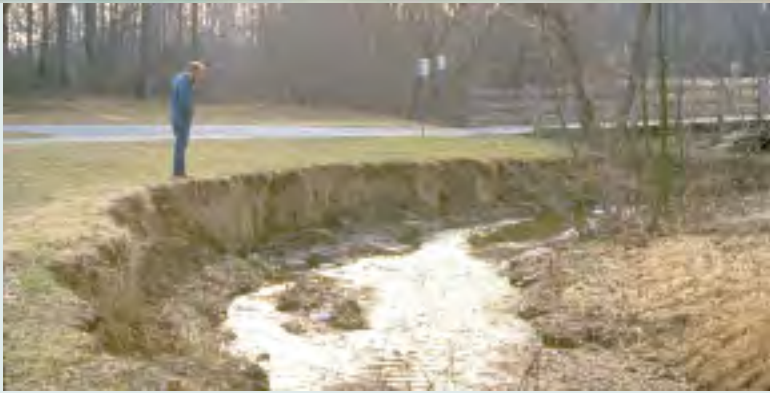
Stormwater can pick up debris, chemicals, dirt, and other pollutants and flow into a storm sewer system or directly to a lake, stream, river, wetland, or coastal water. Anything that enters a storm sewer system is discharged untreated into the waterbodies we use for swimming, fishing, and providing drinking water.

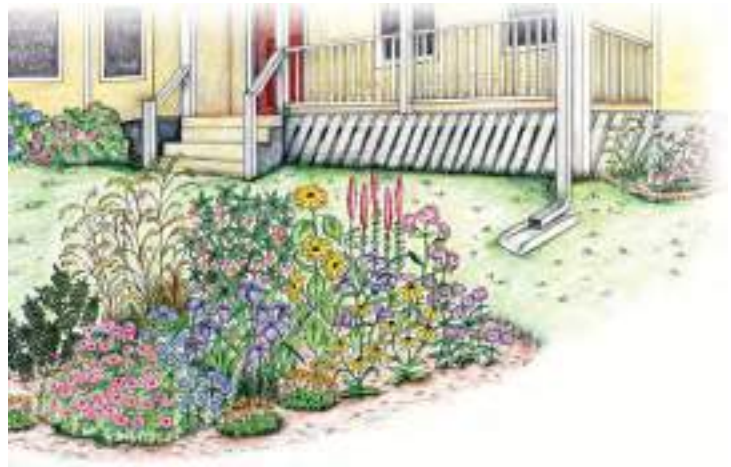
Rain gardens are relatively inexpensive and simple to install. They can be quite diverse and planted with a variety of native perennials, grasses, shrubs and even trees. These landscape features are an easy way to add diversity to your yard while also helping to protect the river from harmful pollutants which can flow in after a rain storm. Sized according to your dwelling's footprint, a strategically located rain garden will collect roof runoff and allow the water to seep into the ground, where it is filtered and cleaned. The roots of the plants in your rain garden also absorb water and some of the contaminants. Additionally, native plants provide food and habitat for a variety of wildlife, including birds, butterflies and beneficial insects.

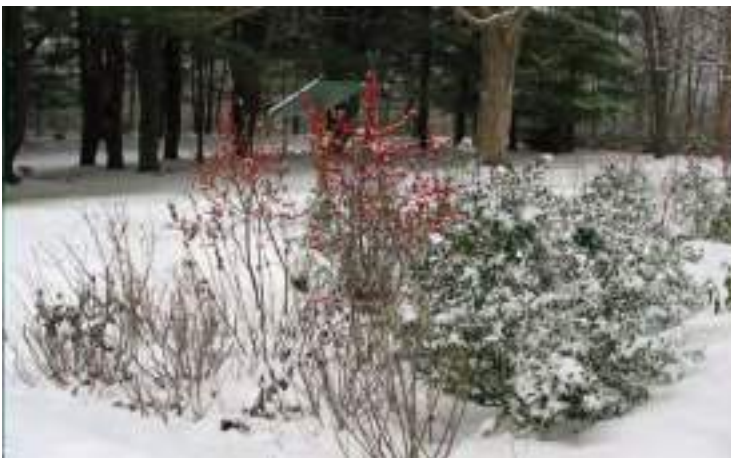
A low-maintenance rain garden in winter. For winter interest, use plants with red berries (e.g. winterberry, red chokeberry) and inkberry, a native evergreen.

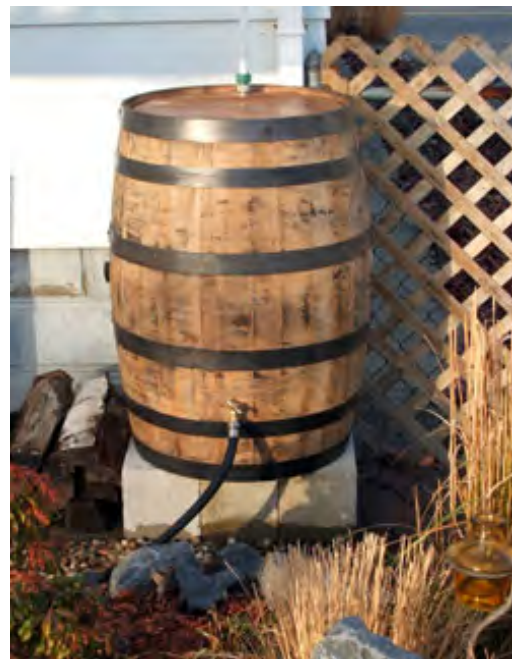
Your gutters can also be retrofitted to attach to a **rain barrel**, which collects and stores rainwater for use in your landscape. Locally-made rain barrels can be purchased from companies, such as the following:
Aaron's Rain Barrels: <http://www.ne-design.net/>
The New England Rain Barrel Company: <http://www.nerainbarrel.com/>

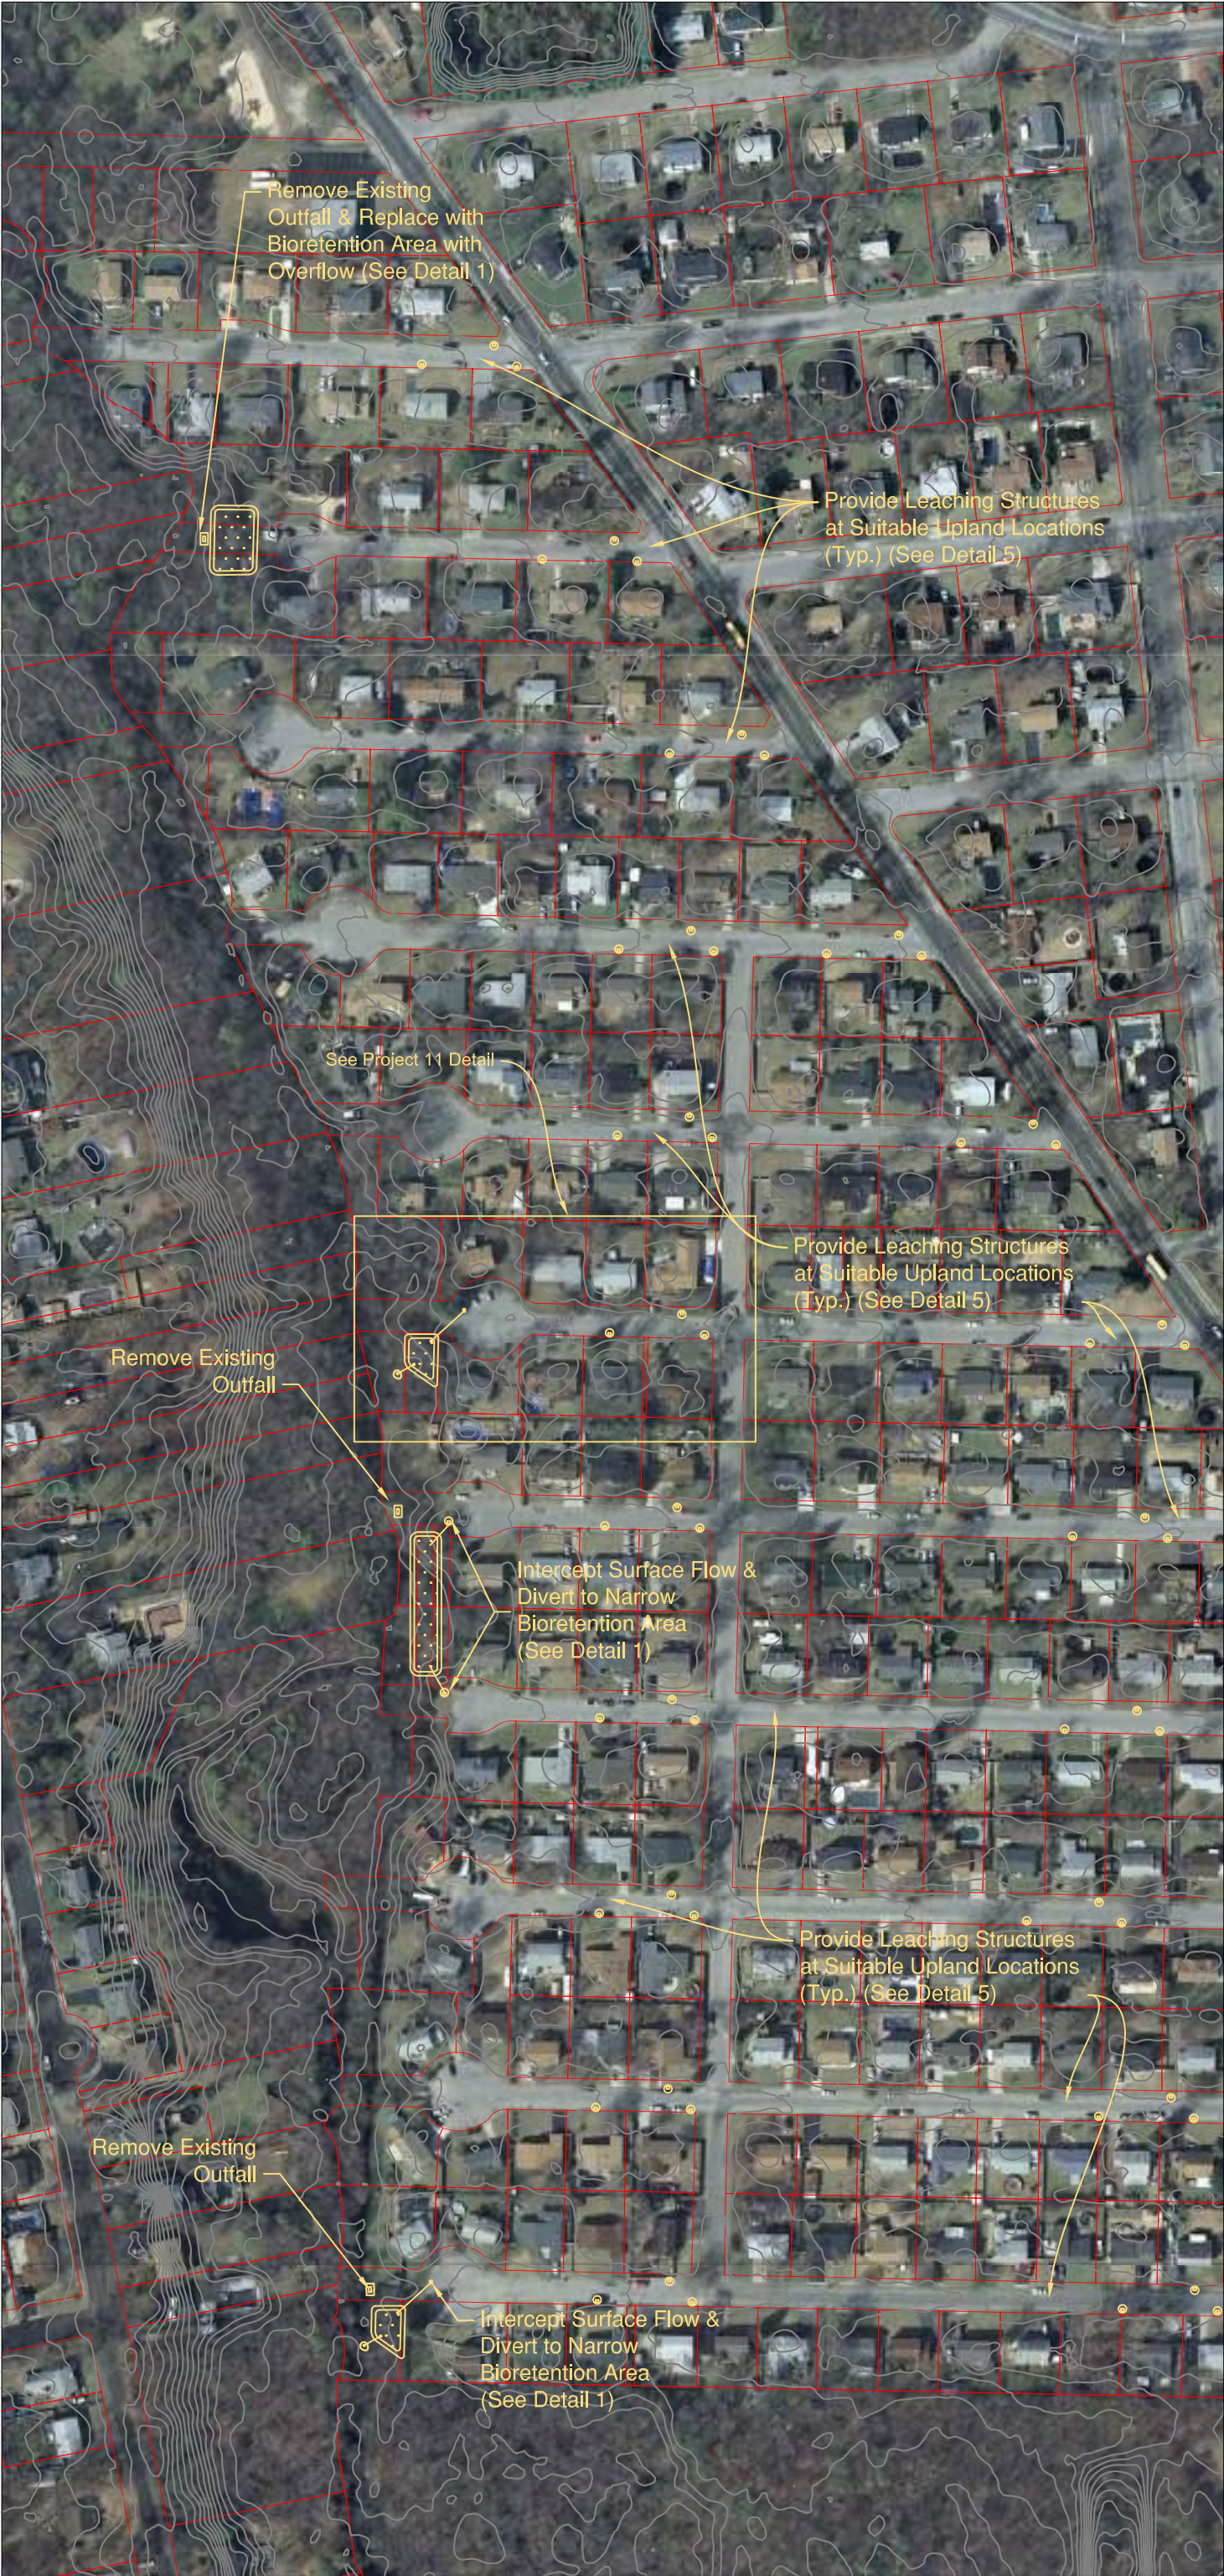
- Suffolk County Tax Parcels
- Topographic Contour
- Proposed Drainage Improvements
- Leaching Catch Basin
- Bio-Retention Area
